Oshkosh Grass Matting Company
(Deltax Complex)
35 Wisconsin Street
Oshkosh
Winnebago County
Wisconsin

HAER No. WI-11

HISTORIC AMERICAN ENGINEERING RECORD

Oshkosh Grass Matting Company
(Deltex Complex)

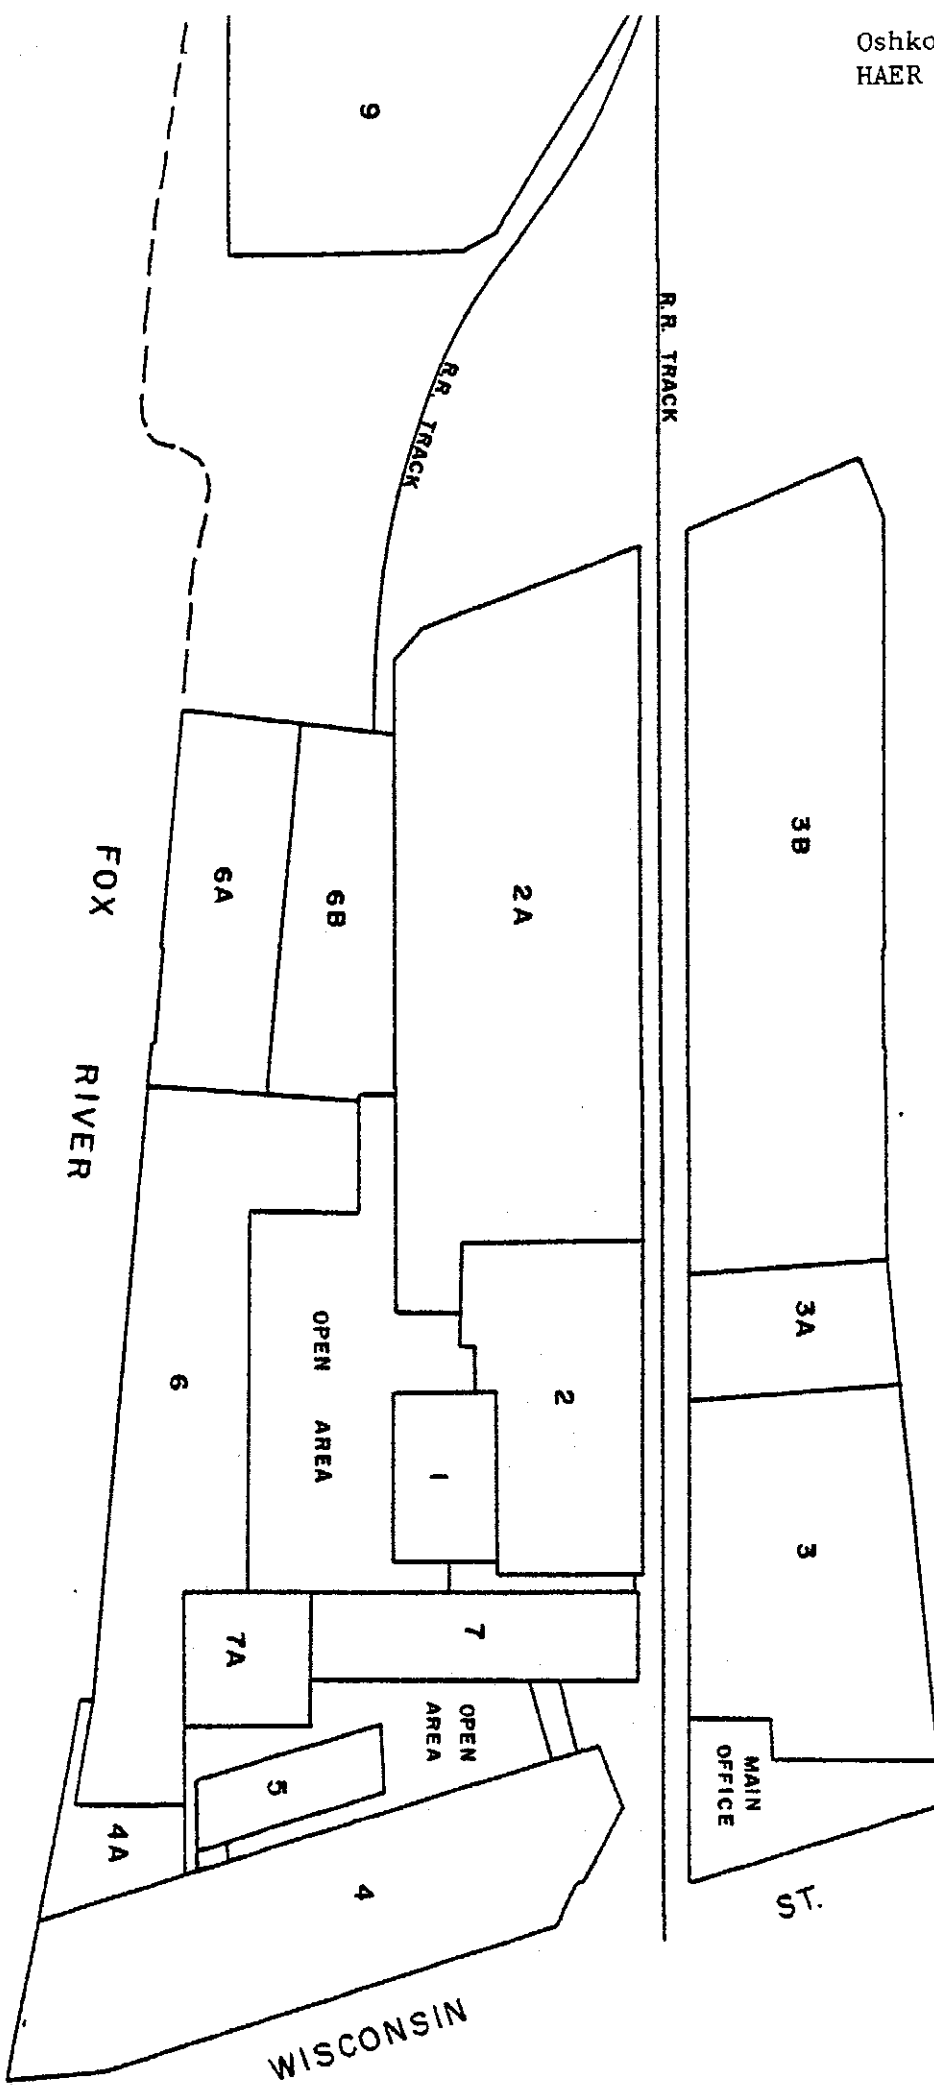
OSHKOSH GRASS MATTING COMPANY
DELTOX COMPLEX

Following is a description of the present and original physical appearance of structures within the Delttox Complex. Building identification corresponds with map # I. All buildings are industrial structures which reflect the era in which they were built. No architects were involved. Fluor Brothers Construction Company, Oshkosh, Wisconsin, built buildings 1, 2, 2A, 3 and 3A. Builders of the other buildings are unknown.
